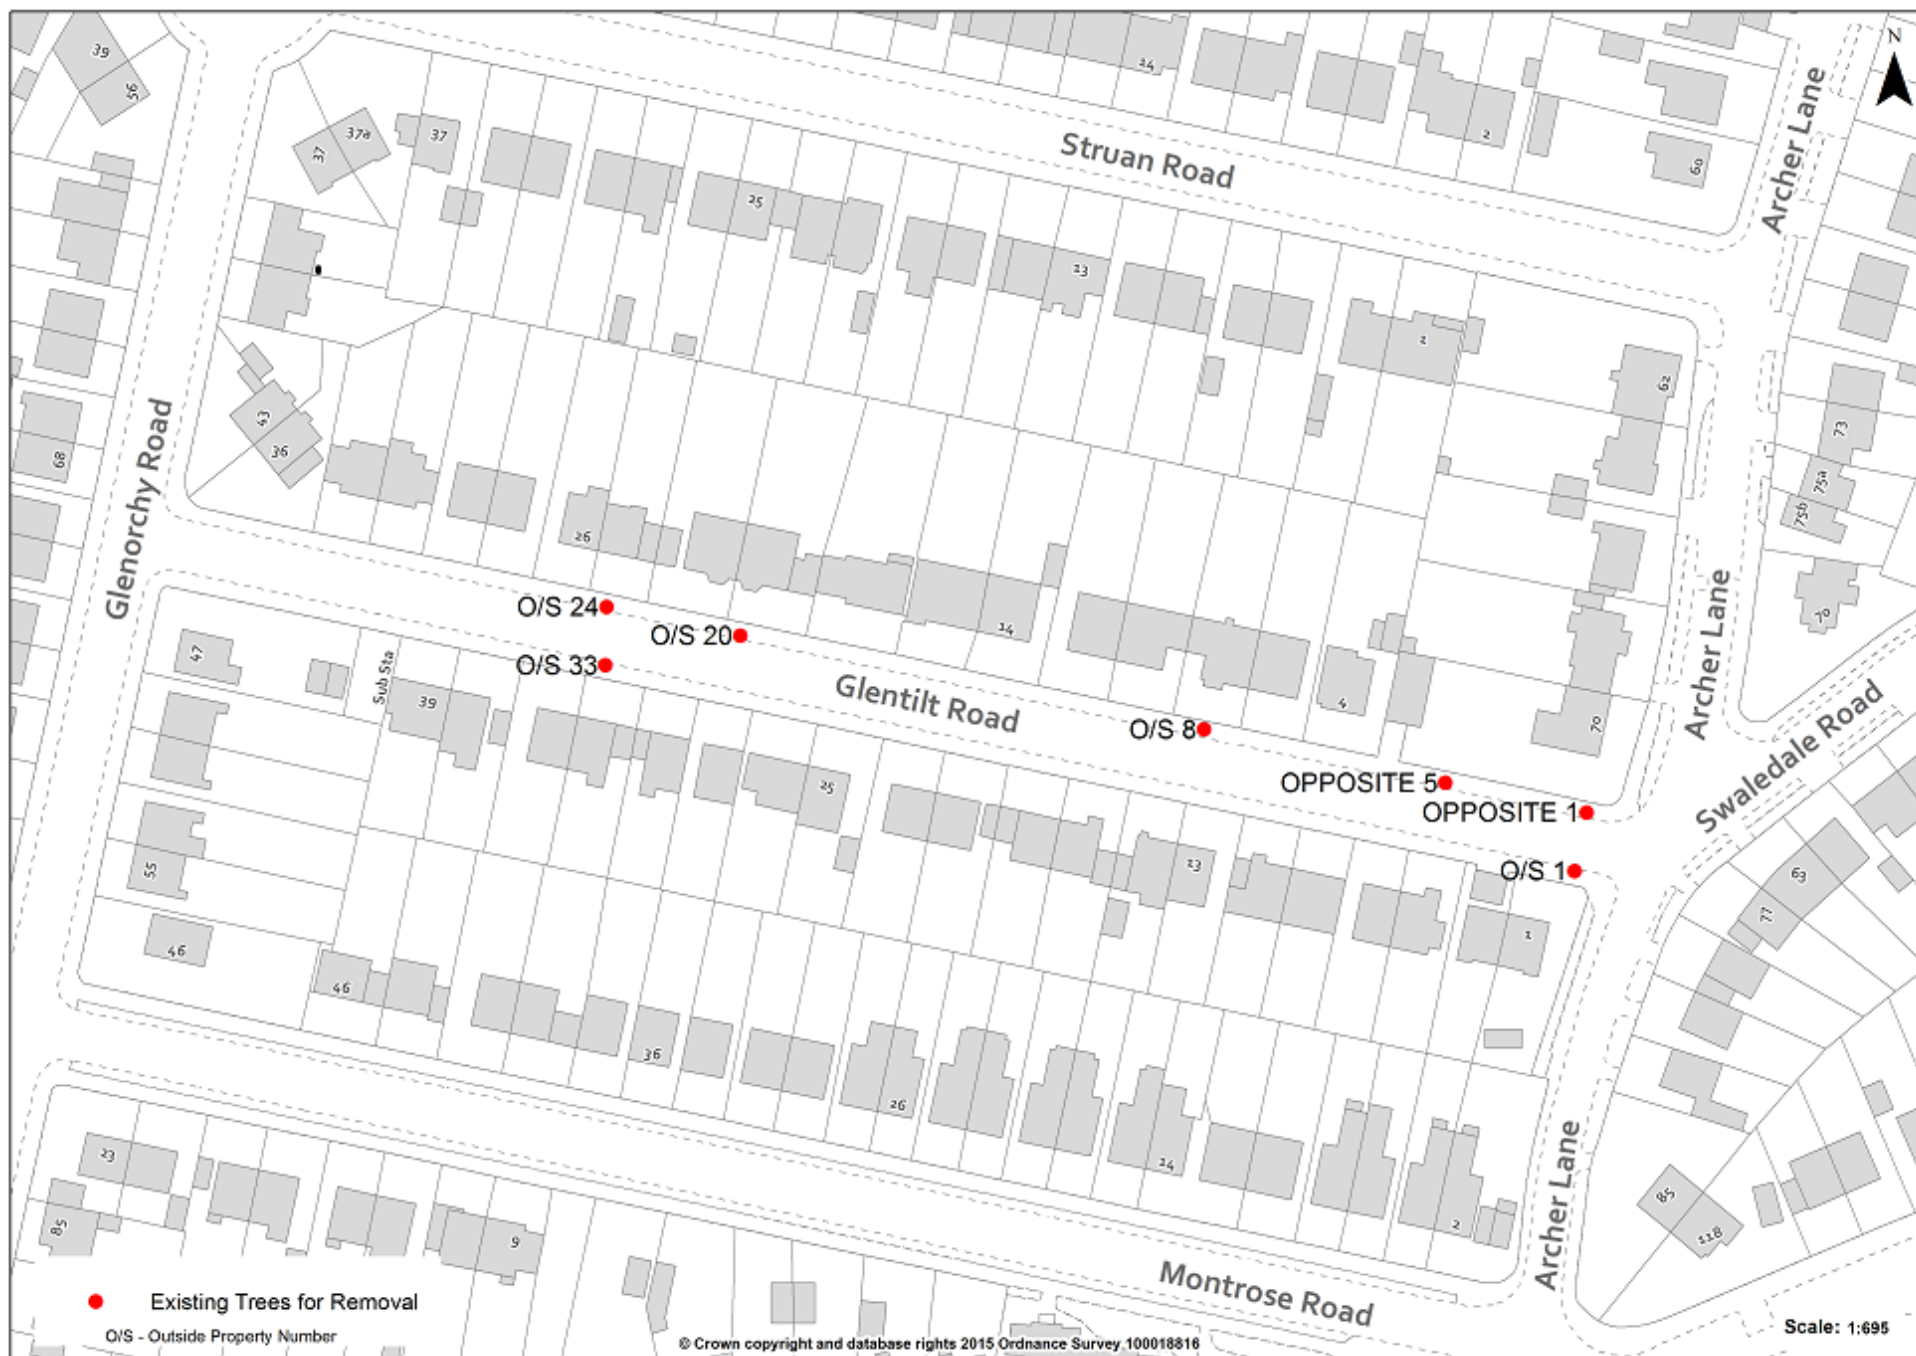
Site Name	Feature Location	6 D's	Reasons	Existing species	Planting notes	Replant species
GLENTILT ROAD	O/S 8	Damaging	Buttress roots growing within c/w - no kerbstones, would be extensively damaged upon road repair	Sorbus intermedia	Plant in new 800mm pit between middle of 8-6 (same as felled tree)	Liquidambar styraciflua 'Worpl
GLENTILT ROAD	O/S 20	Damaging	Kerbs absent - cannot replace without root damage, previously topped - poor structural condition	Fraxinus excelsior	Plant in new 800mm pit o/s 20 (same as felled tree)	Corylus colurna
GLENTILT ROAD	OPPOSITE 5	Dangerous	Previously topped - poor structural condition, weakly attached regrowth on decaying topping points	Fraxinus excelsior	Plant in new 800mm pit opp 5 (same as felled tree)	Corylus colurna
GLENTILT ROAD	OPPOSITE 1	Dangerous	Previously topped - poor structural condition, weakly attached regrowth on decaying topping points	Fraxinus excelsior	Plant in new 800mm pit opp 1 (same as felled tree)	Liquidambar styraciflua 'Worpl

GLENTILT ROAD	O/S 1	Damaging	Buttress roots growing within c/w - no kerbstones, would be extensively damaged upon road repair	Platanus x hispanica	Plant in new 800mm pit o/s 1 (same as felled tree)	Liquidambar styraciflua 'Worpl
GLENTILT ROAD	O/S 24	Damaging	Kerbs pushed into c/w by buttress root pressing immediately on kerb rear - cannot realign	Sorbus intermedia	Plant in new 800mm pit o/s 24 (same as felled tree)	Liquidambar styraciflua 'Worpl
GLENTILT ROAD	O/S 33	Damaging	Kerbs pushed into c/w by buttress root pressing immediately on kerb rear - cannot realign	Sorbus intermedia	Plant in new 800mm pit o/s 33 (same as felled tree)	Liquidambar styraciflua 'Worpl
